## Barriers and glass infills for balustrades

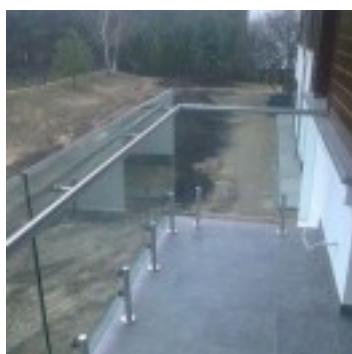
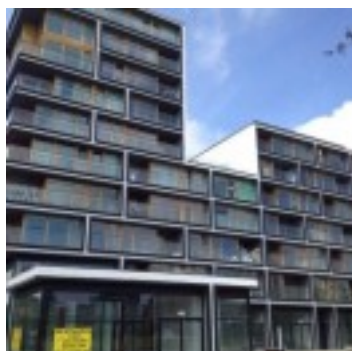
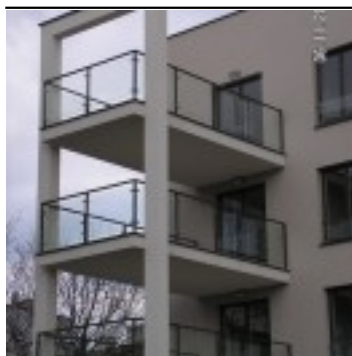
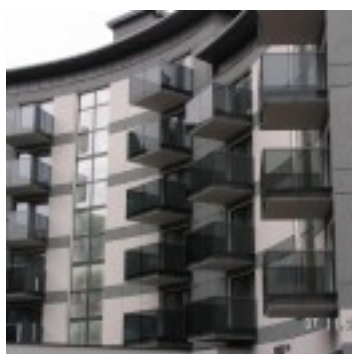
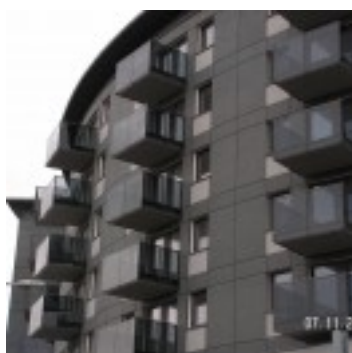
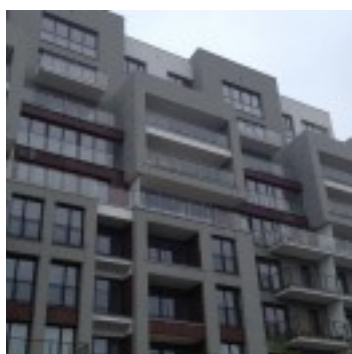
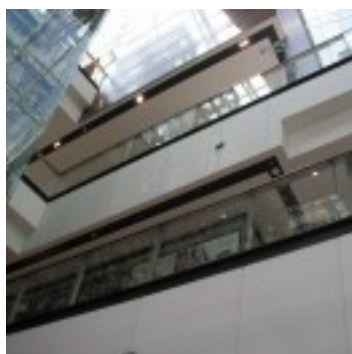
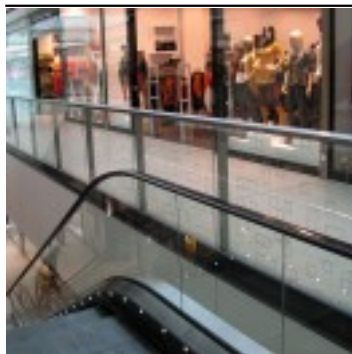
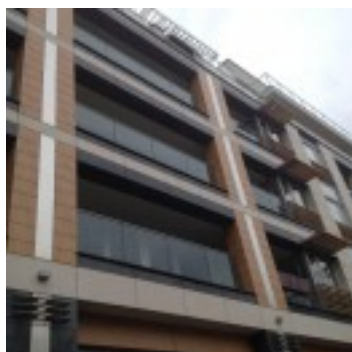
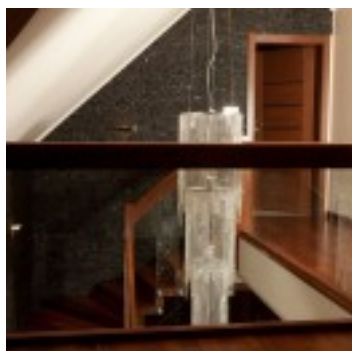
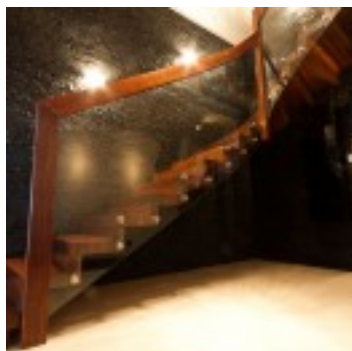
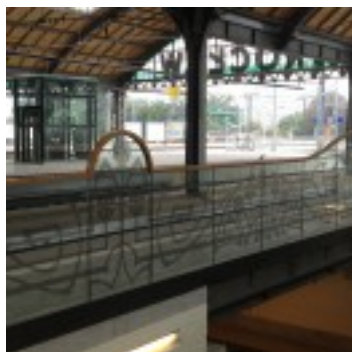
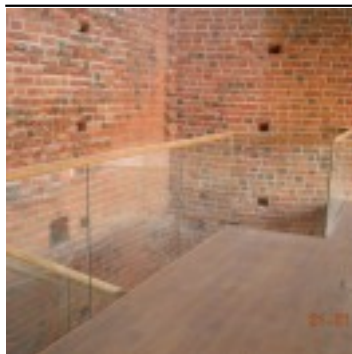
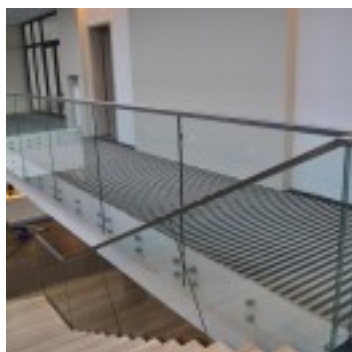
Below are a few example photos of projects using Dubiel Vitrum’s glass.
